Case Study: Cherokee Village

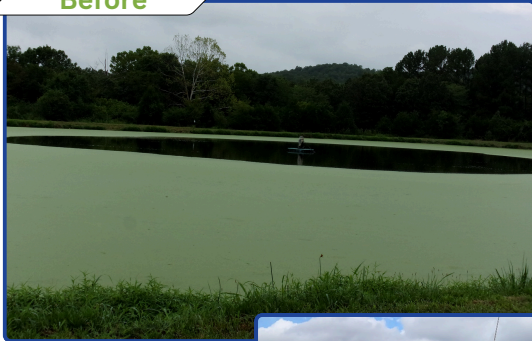
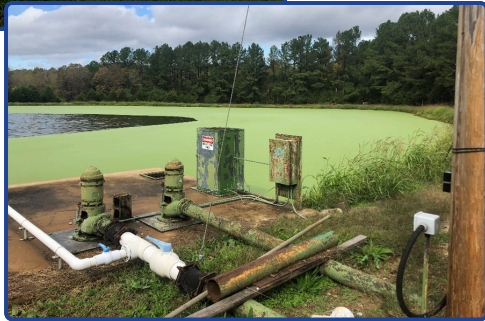
Before

When St. Joseph's Glen acquired the Cherokee Village Wastewater Treatment Facility, the system was plagued by several issues, including noncompliance with effluent limits and operational inefficiencies. The lagoon, a critical component of the facility, had settled sludge at the bottom that required immediate attention to prevent further degradation of the wastewater treatment process. Additionally, overgrown vegetation on the lagoon banks and effluent sand beds hindered maintenance efforts, while the site's fencing and chlorine disinfection housing were in need of repairs.

St. Joseph's Glen took decisive action to address these challenges. The company installed a new lagoon aerator to enhance the treatment process and improve compliance with effluent standards. Remote monitoring technology was introduced, enabling operators to receive real-time alerts on critical components like pump and blower performance. This innovation drastically reduced response times, allowing for more efficient maintenance and operations.

In addition to the lagoon upgrades, St. Joseph's Glen repaired the lift station fencing and replaced outdated pumps, upgrading the panels for better reliability. The chlorine system was also improved, with the addition of a gas detector, scales, regulator, and ventilation, ensuring the safety and effectiveness of the disinfection process. Further enhancements included the installation of a generator quick connect to provide electricity during power outages, ensuring the plant could operate continuously.
